Manhole Inspection Summary

Manhole # S27G__025MH

Insp Date: **5/20/08 11:15 AM**

Location Address: **919 N Poppleton St** Cross Street: **W Fayette**

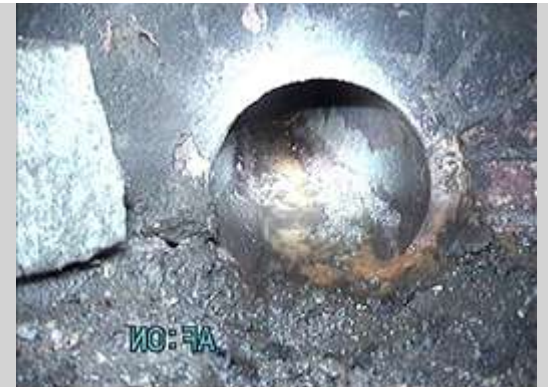
12 O'Clock Outflow

8 in. Circular Gravity Sewer
Pipe Out @ 12 O'Clock

Pipe Height: **8.4** (in.) Rod and Bar (Angled)

Pipe Material: **Clay** ☐ Pipe Lined

Infiltration: **None** Pipe Seal Cond: **Sound**
